Manhole Inspection Summary

Manhole # S17K__053MH

Location Address: **137 S WARWICK AVE - REAR** Cross Street: **FREDERICK RD**

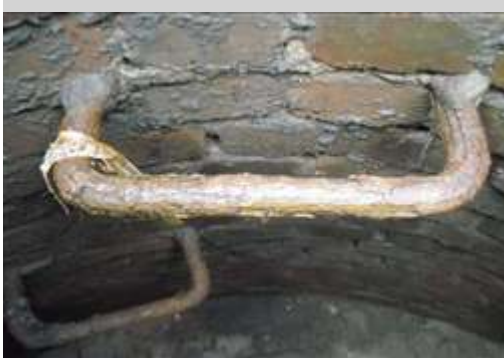
Defect 3

Steps Count: **2** Missing: **0** ☒ Corroded

STEPS BEGINNING TO CORRODE

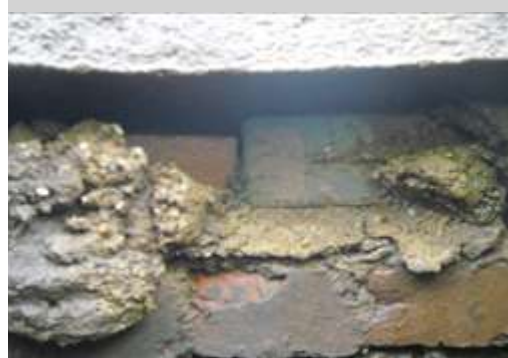
Defect 2

Chimney / Frame Adjustment ☒ Exists Material: **Brick** ☐ Parged Height: **4** (in.)
Condition: ☐ Sound ☐ Cracked ☐ Root Intrusion ☒ Loose Brick ☒ Deteriorated
Infiltration: ☒ None ☐ Joint ☐ Cracks ☐ Mortar ☐ Roots ☐ Wall

CHIMNEY ADJUSTMENT 4" DETERIORATED AND WITH LOOSE BRICKS

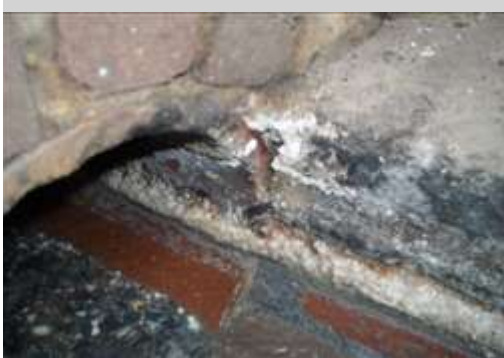
Defect 1

Channel Material: **Brick** ☐ Parged
Channel Exposure: **Fully Open** Junc Dist: **0** nearest .5 ft. Azimuth: **0**
Condition: ☒ Sound ☐ Cracked ☐ Root Intrusion ☒ Deteriorated ☐ Leaks ☐ Debris

CHANNEL CRACKED PIPE SEAL ON 12 OCLOCK

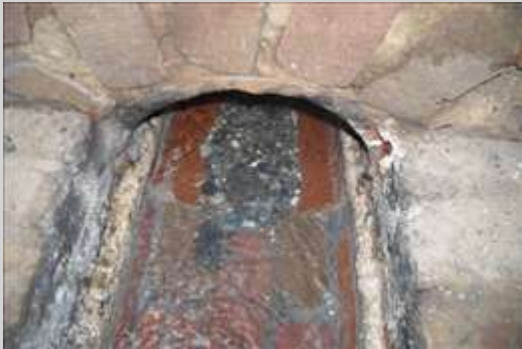
12 O'Clock Outflow

1" BUILDUP OF GREASE ON SIDES OF
CHANNEL, SMALL GRAVEL IN PIPE

Deposits: ☐ None ☐ Mud ☐ Sludge ☒ **Debris** ☐ **Grease**

Silt Depth: **2** (in.) Deposits Extent: **Light**

Infiltration: **None** Pipe Seal Cond: **Cracked**

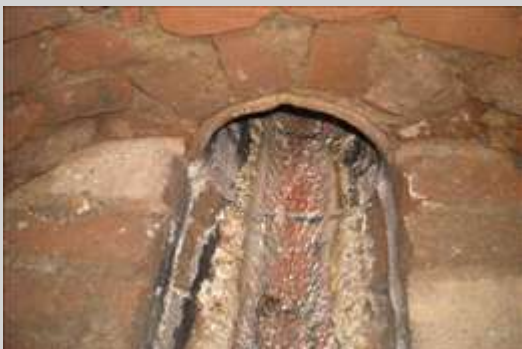
6 O'Clock Inflow

1" BUILDUP OF GREASE ON SIDES OF
PIPE AND CHANNEL

Deposits: ☐ None ☐ Mud ☐ Sludge ☐ Debris ☒ **Grease**

Silt Depth: **1** (in.) Deposits Extent: **Light**
